# NASA Technical Memorandum 80219

## ELECTRONIC EQUIPMENT VULNERABILITY TO FIRE-RELEASED CARBON FIBERS

RICHARD A. PRIDE, AUSTIN D. MCHATTON,  
AND KENNETH A. MUSSELMAN

SEPTEMBER 1980

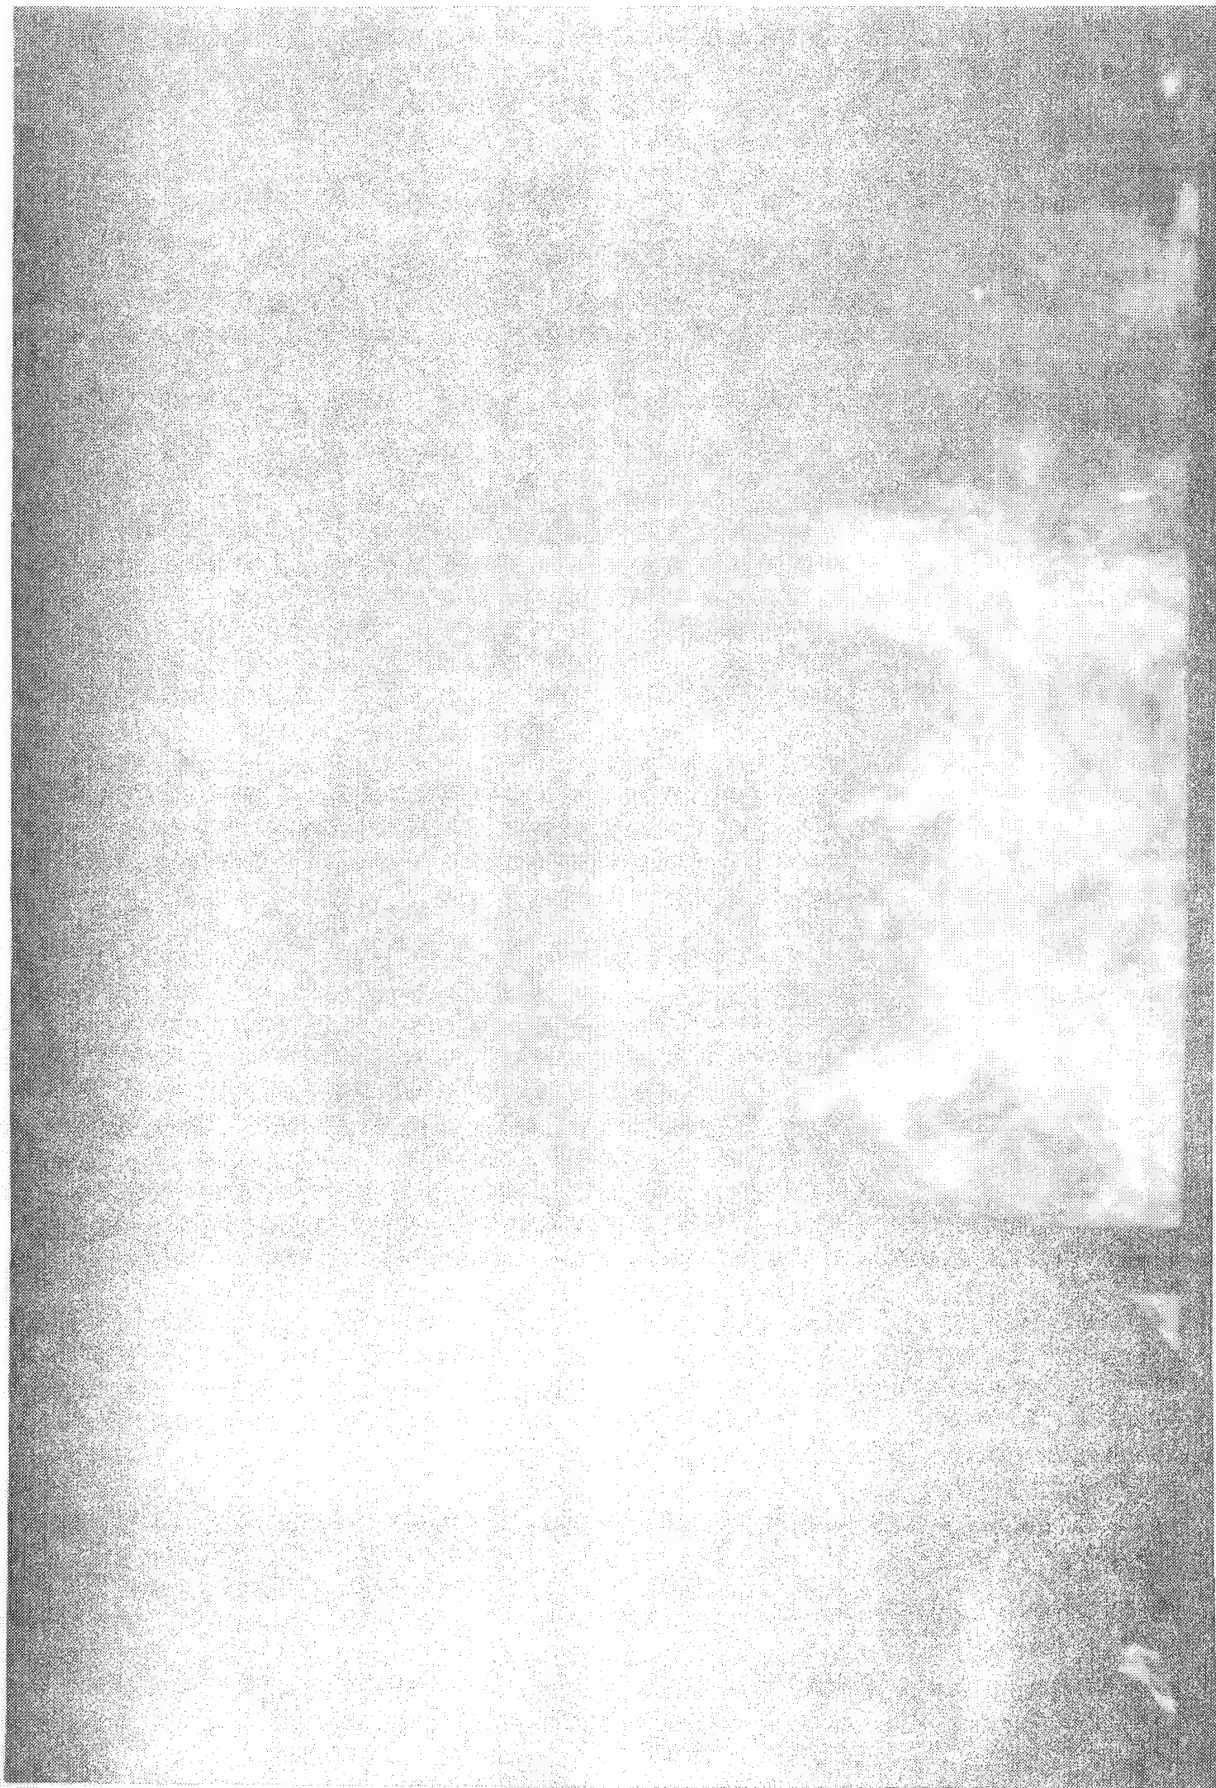
Figure 26.- Carbon-fiber-epoxy composite material in rotating basket being burned in aviation jet fuel fire.

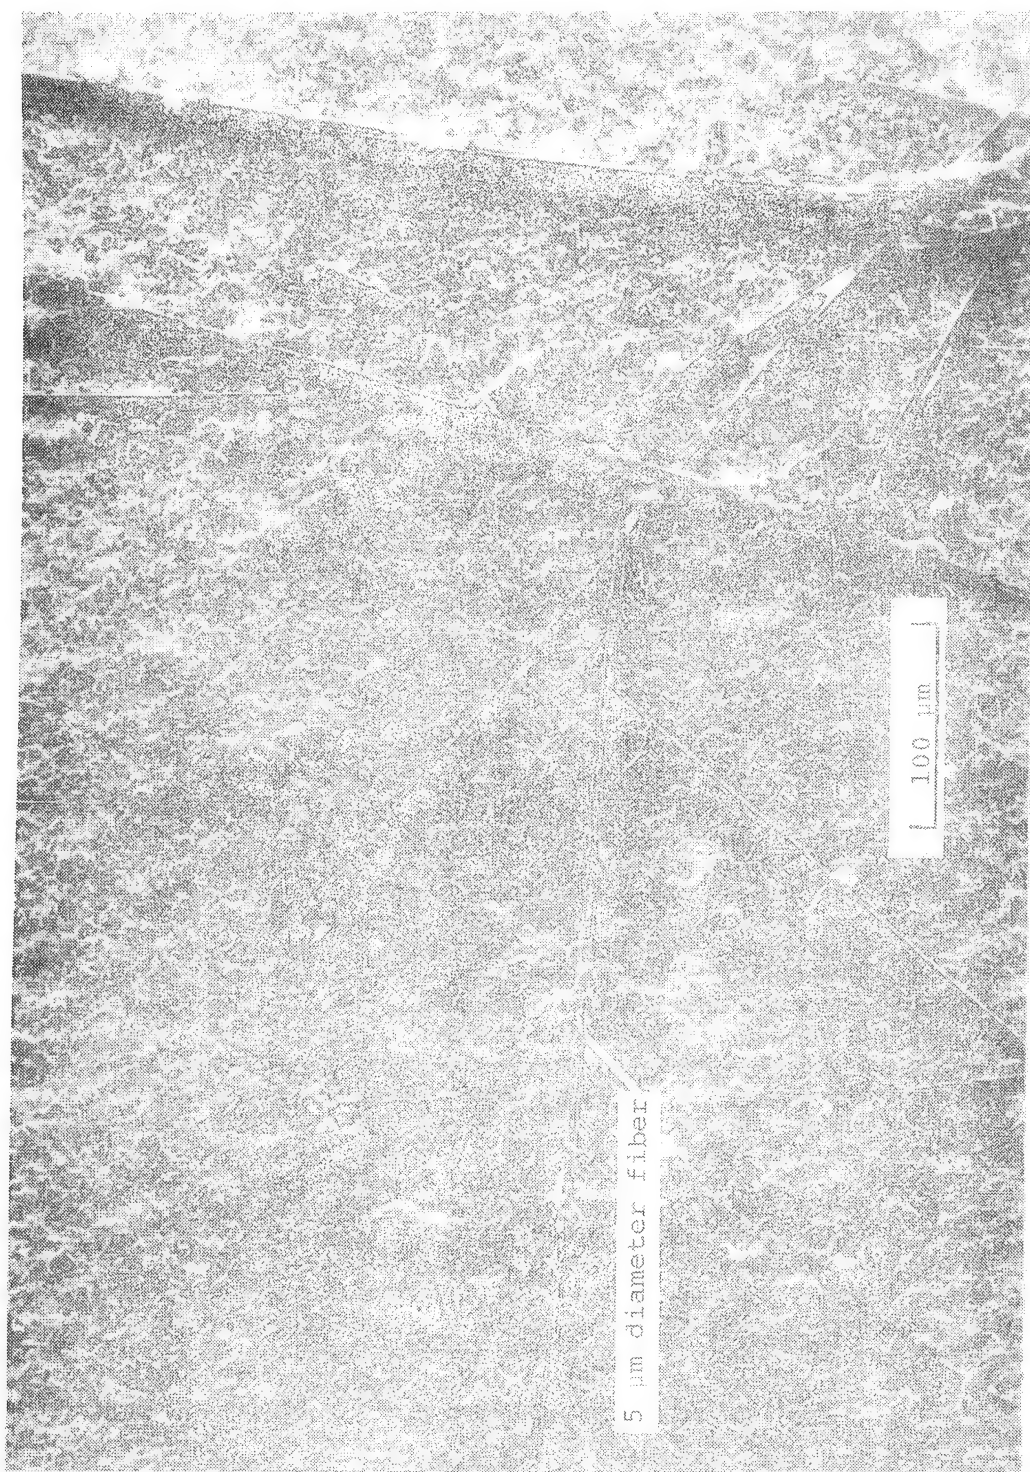
Figure 41.- Scanning electron micrograph of fire-released carbon fibers washed out of soot on screen of canister collector.
